Interesting Outcomes in a Comparison of Biodynamic and Conventionally Managed Soils – Callawadda, Victoria, Australia

Dr John Russell, Lecturer at La Trobe University, Bendigo, Victoria, j.russell@latrobe.edu.au

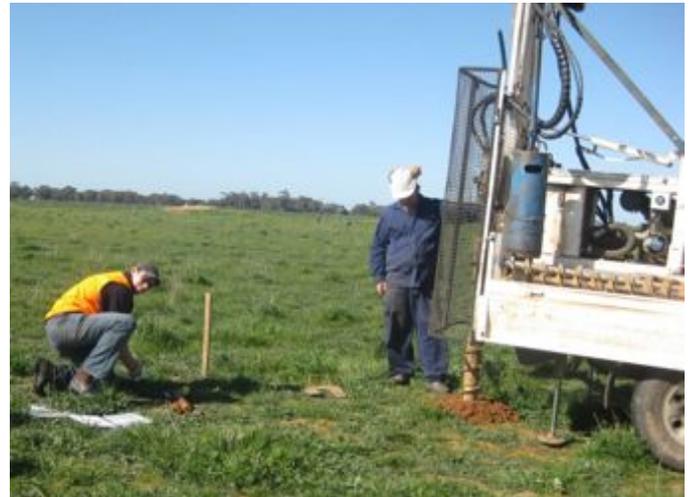
Figure 1 showing the Hydraulic Coring machine in operation and a student dissecting a soil core.

The investigation was carried out using standardised physical and chemical procedures. Soil samples were taken to a depth of 1.1 metres using a hydraulic corer. There were four separate soil cores taken to make up a sample of soil. Each core was dissected to eight samples. I.e. 0-50; 50-100; 100-200; 200-300; 300-500; 500-700; 700-900; 900-1100mm and the averaged sample was analysed in the laboratory for a suite of parameters including total organic carbon using the Shimadzu Total

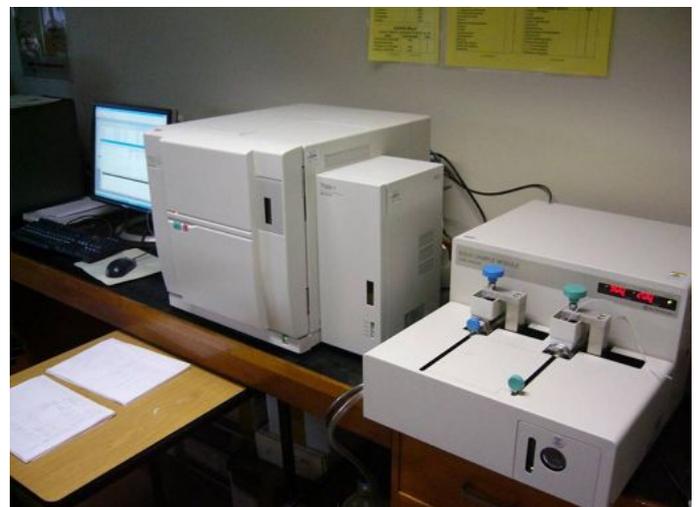
Figure 2 showing the Shimadzu Total Organic Carbon Analyser Solid Sample Module.

Organic Carbon Analyser Solid Sample Module as shown in figure 2.

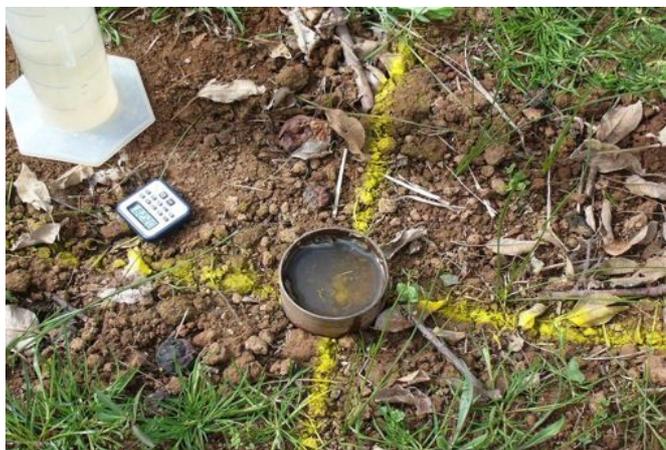
Figure 3 showing a soil infiltration test in progress.

A typical soil infiltration on-site test is shown in figure 3 where the infiltration of quantities of added water are measured and recorded as a function of time which is usually in excess of one hour.

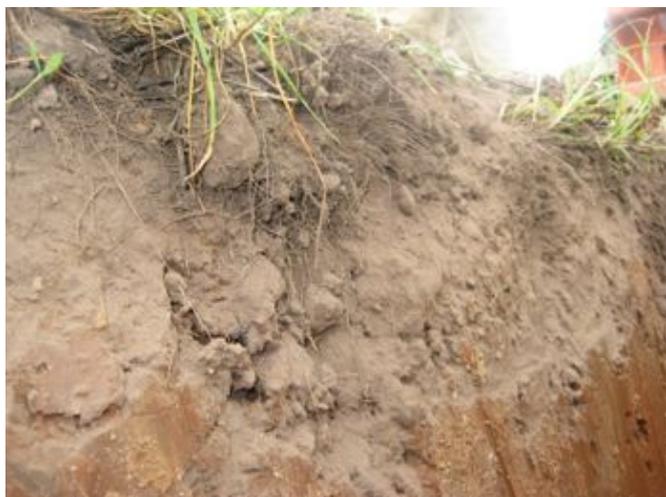
Figure 4 showing the soil profile developing into a suspected deep ripped line.

The soil is classified as Red and Yellow Sodosols. On the biodynamic managed property an uneven deepening soil profile was found as is shown in figure 4. This uneven profile was attributed to earlier deep ripping of the paddock. The conventional managed property had not been deep ripped and did not display an uneven deepened profile.
